Flood Control Project Maintenance**2013 Structure Summary Report****Overall Unit and Item Ratings****San Joaquin County Flood Control and Water Conservation District****Duck Creek Diversion Weir And Control Structure**

Flood Control Project Maintenance**Unit Cover Sheet****2013 Structure Inspection Results****San Joaquin County Flood Control and Water Conservation District**

Structure
Duck Creek Diversion Weir And Control Structure

Structure Rating	A
Date of Inspection	07/10/2013
DWR Inspector	Pavel Kazi
Accompanied By	Jim Caruso SJCF&WCD
	Jay Jauregui

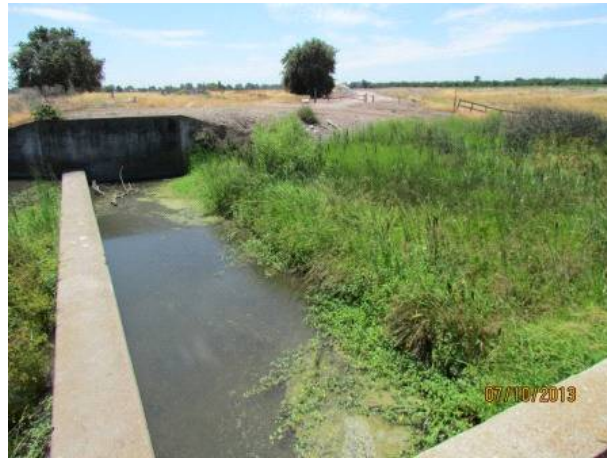
Levee Mile Report Line	2
Start Levee Mile	0.00
End Levee Mile	0.00
Location	
Category	Structures
Item	Vegetation & Obstructions

View of the vegetation around the structure looking downstream.

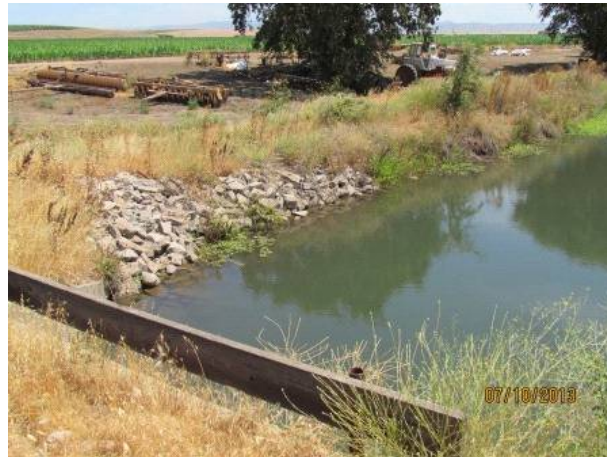
Levee Mile Report Line	5
Start Levee Mile	0.00
End Levee Mile	0.00
Location	
Category	Structures
Item	Revetments

View of the existing revetments.

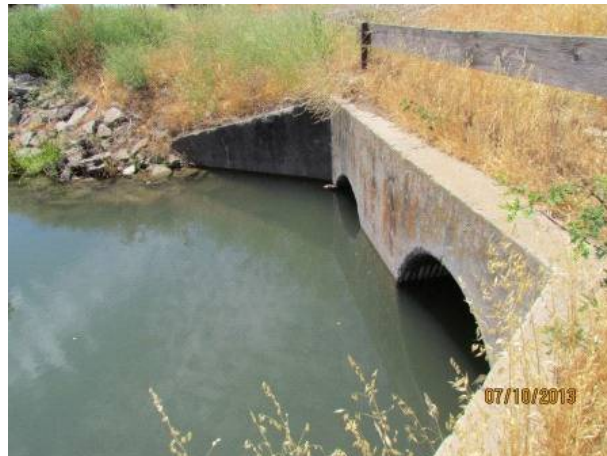
Levee Mile Report Line	7
Start Levee Mile	0.00
End Levee Mile	0.00
Location	
Category	Structures
Item	Culverts: Inlets / Outlets

View of the inlet of the culvert.

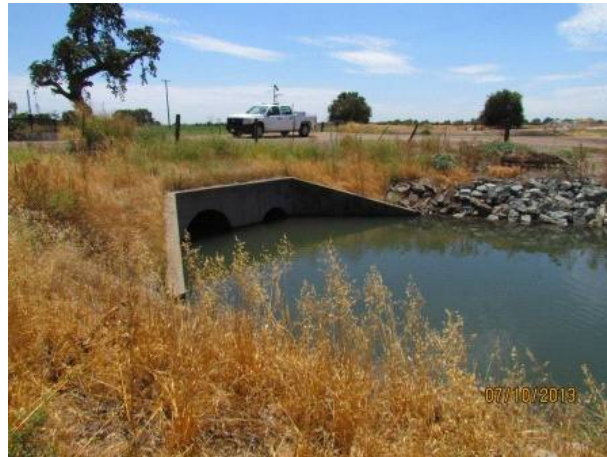
Levee Mile Report Line	7
Start Levee Mile	0.00
End Levee Mile	0.00
Location	
Category	Structures
Item	Culverts: Inlets / Outlets

View of the outlet of the culvert.

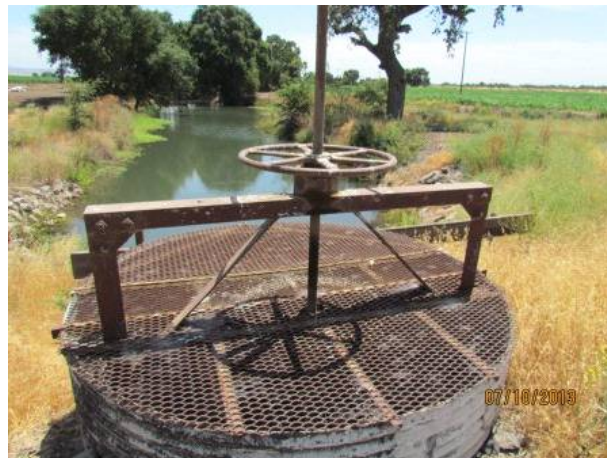
Levee Mile Report Line	12
Start Levee Mile	0.00
End Levee Mile	0.00
Location	
Category	Structures
Item	Sluice/Slide Gates

11	0.00	0.00	Structures	Flap Gates		N	Inspector Comments: No flap gates were present at this structure.	37.938383 ° -120.990133 °	37.938383 ° -120.990133 °	11
12	0.00	0.00	Structures	Sluice/Slide Gates		A	Inspector Comments: The gates appeared to be in good working condition.	37.938383 ° -120.990133 °	37.938383 ° -120.990133 °	12 Y
13	0.00	0.00	Structures	Electric Gate Operators		N	Inspector Comments: No electric gate operator was found at this structure.	37.938383 ° -120.990133 °	37.938383 ° -120.990133 °	13
14	0.00	0.00	Structures	Manual Gate Operators		A	Inspector Comments: The manual gate appeared to be operational.	37.938383 ° -120.990133 °	37.938383 ° -120.990133 °	14

View of the slide gate.

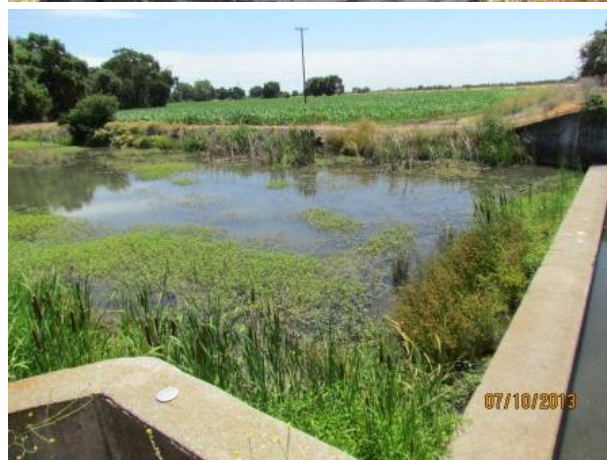
Levee Mile Report Line	15
Start Levee Mile	0.00
End Levee Mile	0.00
Location	
Category	Structures
Item	Concrete Surfaces

LMR No.	Levee Mile		Category	Item	Location *	Rating **	Action/Comment	GPS Latitude/Longitude		Issue No.
	Start	End						Start	End	Photo
15	0.00	0.00	Structures	Concrete Surfaces		A	Inspector Comments: The concrete surfaces had minor cracking and the surface was weathered but they didn't pose any threats to the integrity of the structure.	37.938383 ° -120.990133 °	37.938383 ° -120.990133 °	15 Y
16	0.00	0.00	Structures	Concrete Tilting / Settlement		A	Inspector Comments: No visible sliding or settlement was found on the structure.	37.938383 ° -120.990133 °	37.938383 ° -120.990133 °	16
17	0.00	0.00	Structures	Concrete Foundations		A	Inspector Comments: No scouring or erosion was found near the structure.	37.938383 ° -120.990133 °	37.938383 ° -120.990133 °	17
18	0.00	0.00	Structures	Security Fencing		N	Inspector Comments: No security fence was found in this structure.	37.938383 ° -120.990133 °	37.938383 ° -120.990133 °	18

View of the weir.

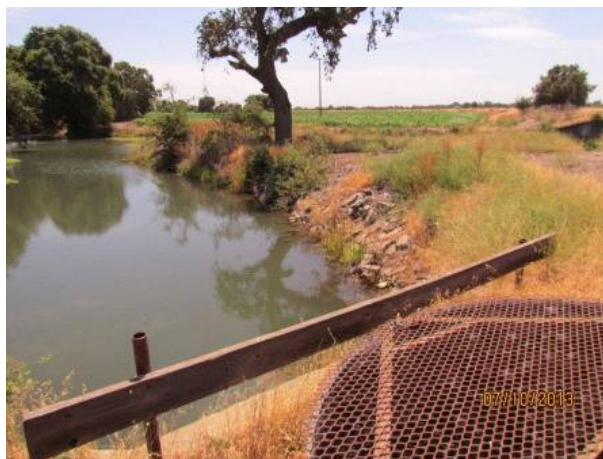
Levee Mile Report Line	23
Start Levee Mile	0.00
End Levee Mile	0.00
Location	
Category	Structures
Item	Safety

View of the railing top of the culvert.

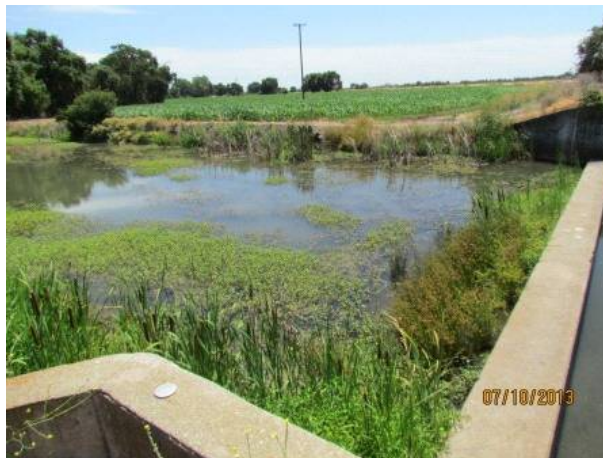
Levee Mile Report Line	24
Start Levee Mile	0.00
End Levee Mile	0.00
Location	
Category	Structures
Item	Photo Documentation

View of the Duck Creek Diversion Weir.

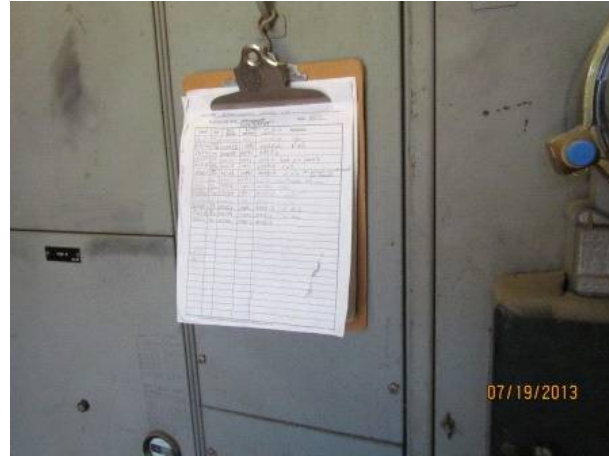
Levee Mile Report Line	1
Start Levee Mile	0.00
End Levee Mile	0.00
Location	
Category	Pump Stations
Item	Operating Log

View of the operation log in the plant.

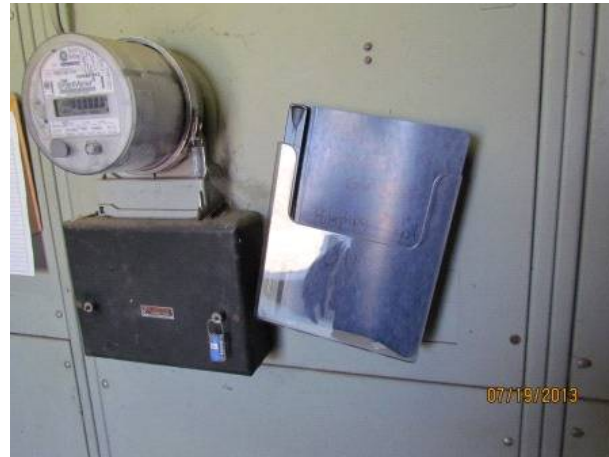
Levee Mile Report Line	2
Start Levee Mile	0.00
End Levee Mile	0.00
Location	
Category	Pump Stations
Item	Operation & Maintenance Manual

View of the O&M manual inside the plant.

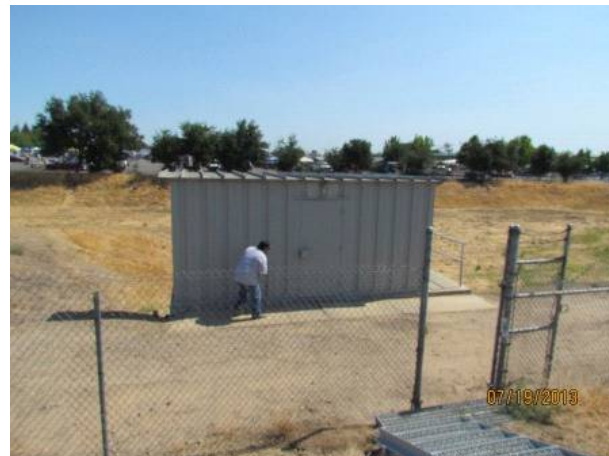
Levee Mile Report Line	3
Start Levee Mile	0.00
End Levee Mile	0.00
Location	
Category	Pump Stations
Item	Plant Building

View of the pumping plant.

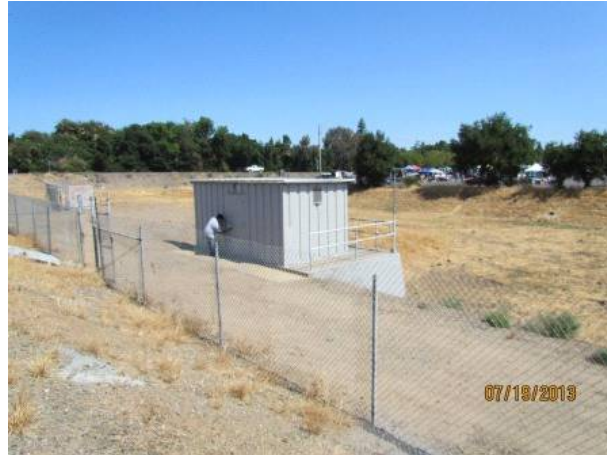
Levee Mile Report Line	5
Start Levee Mile	0.00
End Levee Mile	0.00
Location	
Category	Pump Stations
Item	Safety

View of the guard rails around the plant.

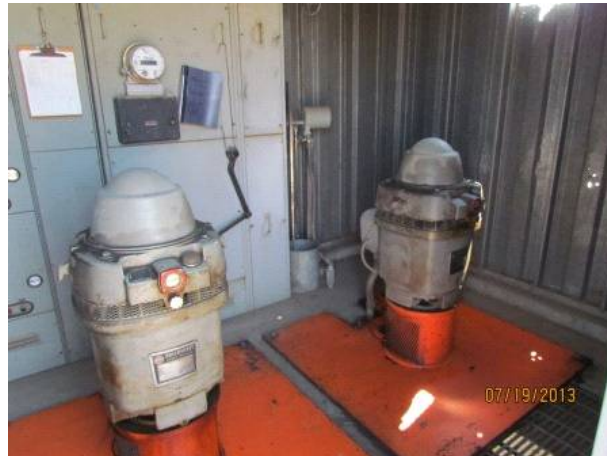
Levee Mile Report Line	7
Start Levee Mile	0.00
End Levee Mile	0.00
Location	
Category	Pump Stations
Item	Pumps

View of pumps inside the plant.

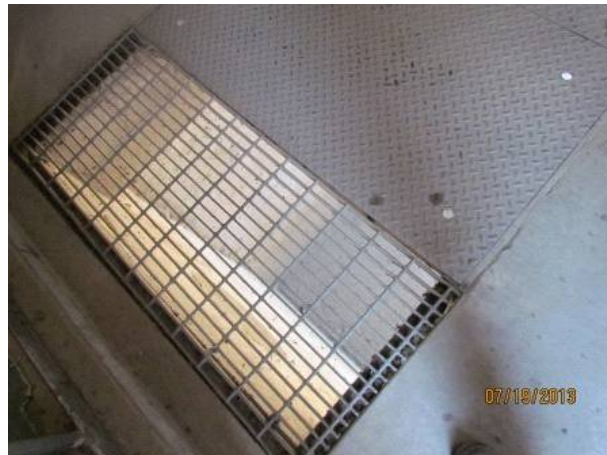
Levee Mile Report Line	11
Start Levee Mile	0.00
End Levee Mile	0.00
Location	
Category	Pump Stations
Item	Sumps/Wet Well

View of the dry wet well.

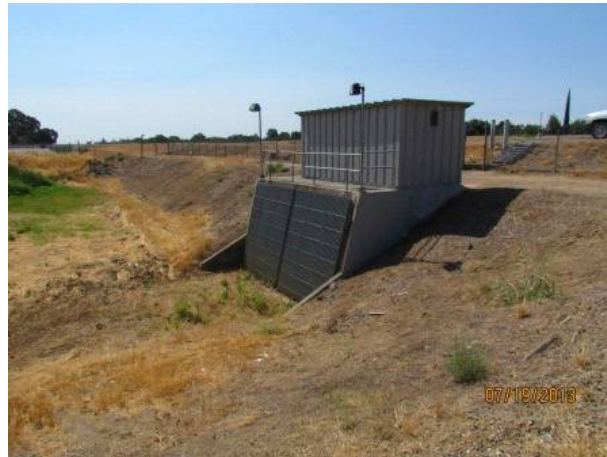
Levee Mile Report Line	12
Start Levee Mile	0.00
End Levee Mile	0.00
Location	
Category	Pump Stations
Item	Trash Racks
View of the trash racks.	
pkazi_t_20130723_236.JPG

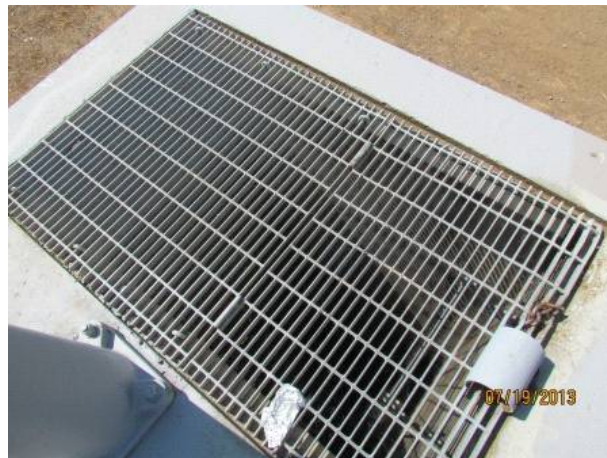
Levee Mile Report Line	14
Start Levee Mile	0.00
End Levee Mile	0.00
Location	
Category	Pump Stations
Item	Sluice / Slide Gates
View of the slide gate well.	
pkazi_t_20130723_237.JPG

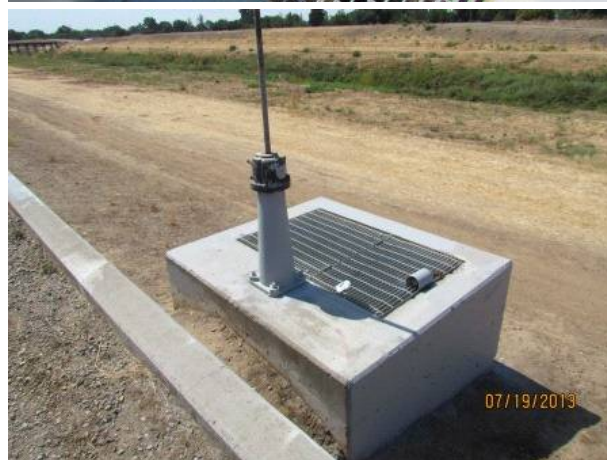
16	0.00	0.00	Pump Stations	Manual Gate Operators		A	Item inspected visually only. Item was not operated during the inspection. Inspector Comments: Manual gate operator was in good operational condition.	37.989633 ° -121.266933 °	37.989633 ° -121.266933 °	17 Y
17	0.00	0.00	Pump Stations	Other Metallic Items		A	Item inspected visually only. Item was not operated during the inspection. Inspector Comments: All metal parts appeared to be in good condition.	37.989633 ° -121.266933 °	37.989633 ° -121.266933 °	18
18	0.00	0.00	Pump Stations	Flap Gates		A	Item inspected visually only. Item was not operated during the inspection. Inspector Comments: The flap gates appeared to be in good working condition.	37.989633 ° -121.266933 °	37.989633 ° -121.266933 °	19 Y
19	0.00	0.00	Pump Stations	Closure Structures		N	Item inspected visually only. Item was not operated during the inspection. Inspector Comments: No closure structure was present at this plant.	37.989633 ° -121.266933 °	37.989633 ° -121.266933 °	20

Levee Mile Report Line	16
Start Levee Mile	0.00
End Levee Mile	0.00
Location	
Category	Pump Stations
Item	Manual Gate Operators
View of the manual gate.	
pkazi_t_20130723_238.JPG

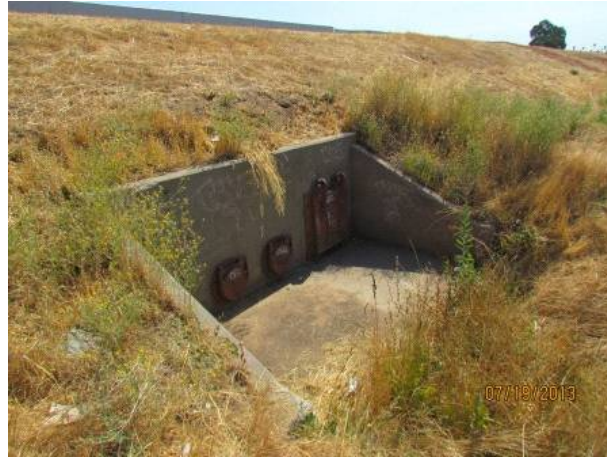
Levee Mile Report Line	18
Start Levee Mile	0.00
End Levee Mile	0.00
Location	
Category	Pump Stations
Item	Flap Gates

View of the flap gates.

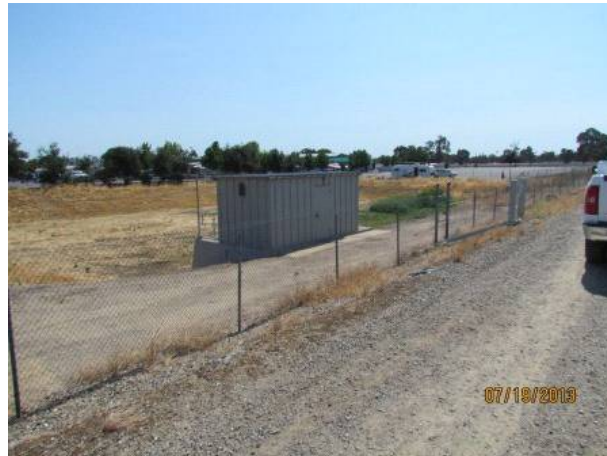
Levee Mile Report Line	20
Start Levee Mile	0.00
End Levee Mile	0.00
Location	
Category	Pump Stations
Item	Security Fencing

20	0.00	0.00	Pump Stations	Security Fencing		M	Item inspected visually only. Item was not operated during the inspection. Inspector Comments: Security fencing appeared to be in good condition.	37.989633 ° -121.266933 °	37.989633 ° -121.266933 °	21 Y
21	0.00	0.00	Pump Stations	Intake and Discharge Pipes		A	Item inspected visually only. Item was not operated during the inspection. Inspector Comments: The pipes appeared to be in good working condition.	37.989633 ° -121.266933 °	37.989633 ° -121.266933 °	22

View of the security fence around the pumping plant.

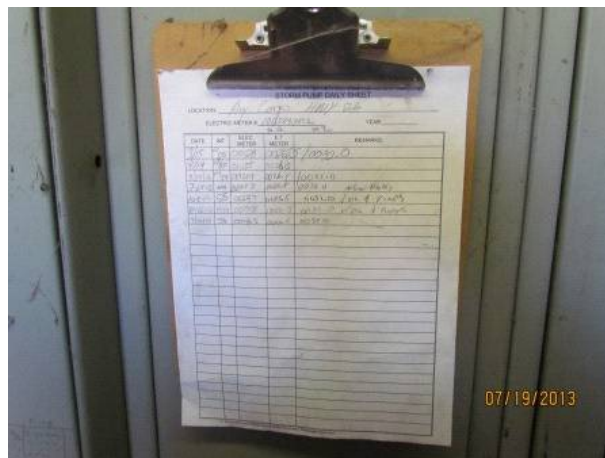
View of the operation log inside the pumping plant.

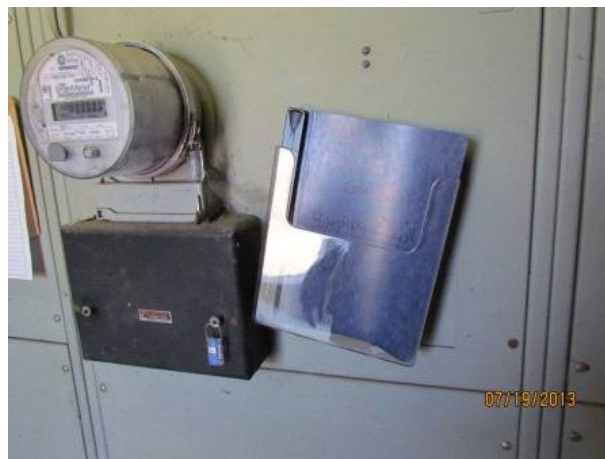
Levee Mile Report Line	2
Start Levee Mile	0.00
End Levee Mile	0.00
Location	
Category	Pump Stations
Item	Operation & Maintenance Manual

View of the O&M manual inside the pumping plant.

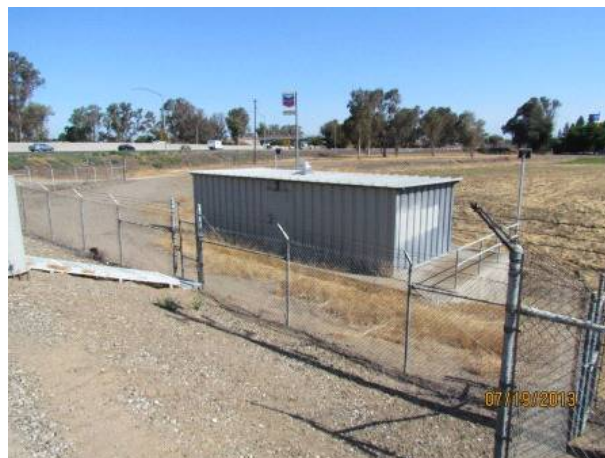
Levee Mile Report Line	3
Start Levee Mile	0.00
End Levee Mile	0.00
Location	
Category	Pump Stations
Item	Plant Building

View of the pumping plant.

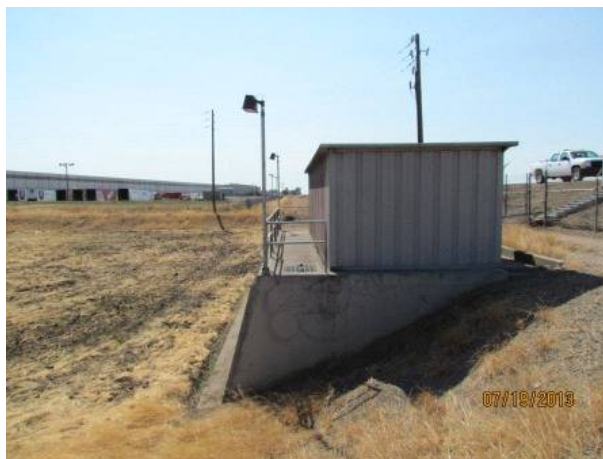
View of the hand rails around the pumping plant.

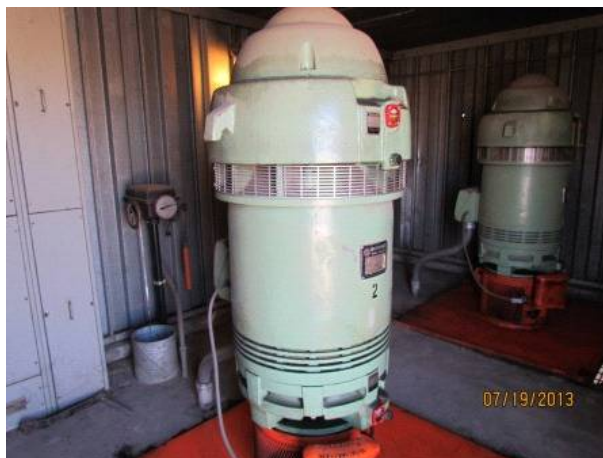
Levee Mile Report Line	7
Start Levee Mile	0.00
End Levee Mile	0.00
Location	
Category	Pump Stations
Item	Pumps

View of the pumps inside the pumping plant.

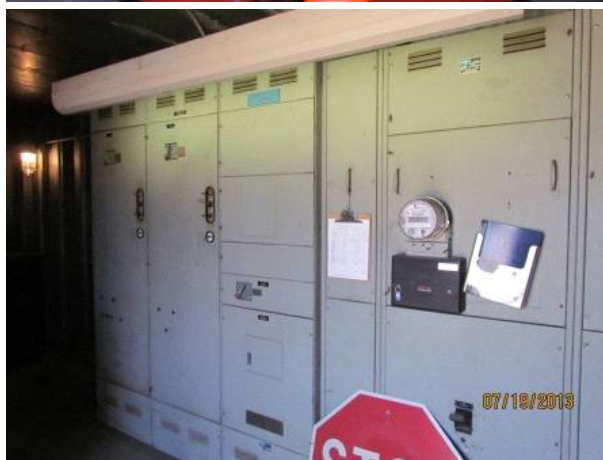
Levee Mile Report Line	10
Start Levee Mile	0.00
End Levee Mile	0.00
Location	
Category	Pump Stations
Item	Pump Control Systems

View of the power control system.

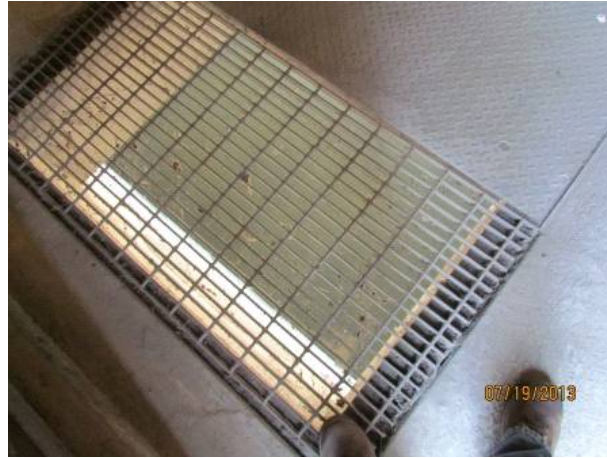
View of the wet well.

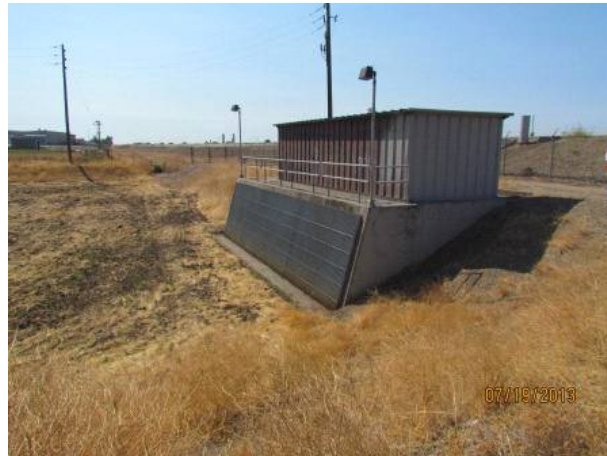
Levee Mile Report Line	12
Start Levee Mile	0.00
End Levee Mile	0.00
Location	
Category	Pump Stations
Item	Trash Racks

View of the trash racks.

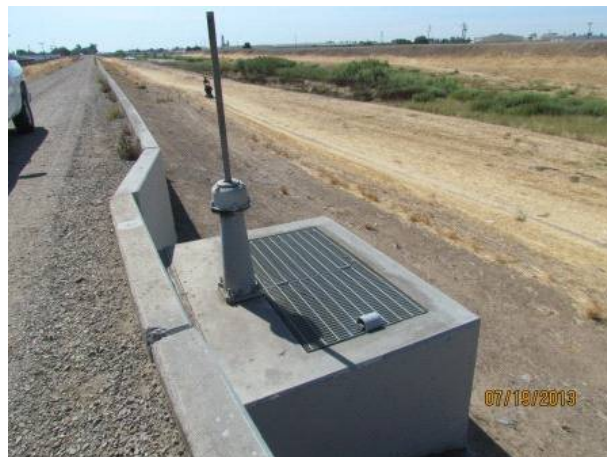
Levee Mile Report Line	14
Start Levee Mile	0.00
End Levee Mile	0.00
Location	
Category	Pump Stations
Item	Sluice / Slide Gates

View of the slide gate.

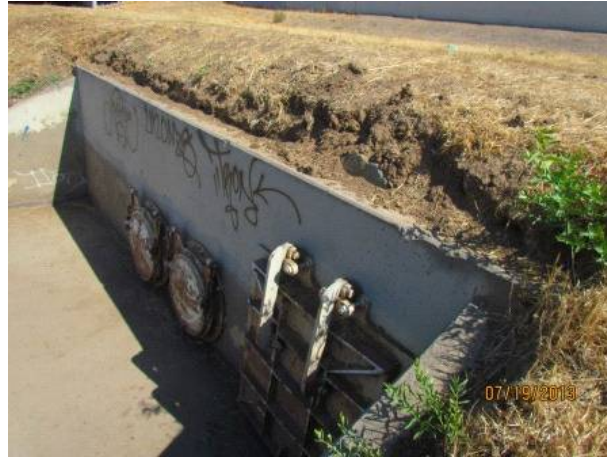
View of the flap gates.

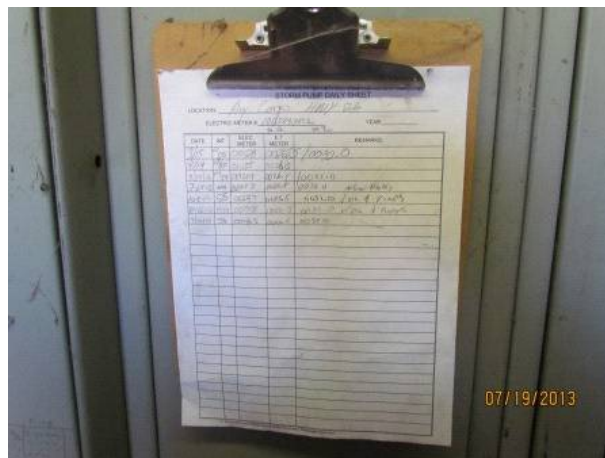
View of the operating log inside the pumping plant.

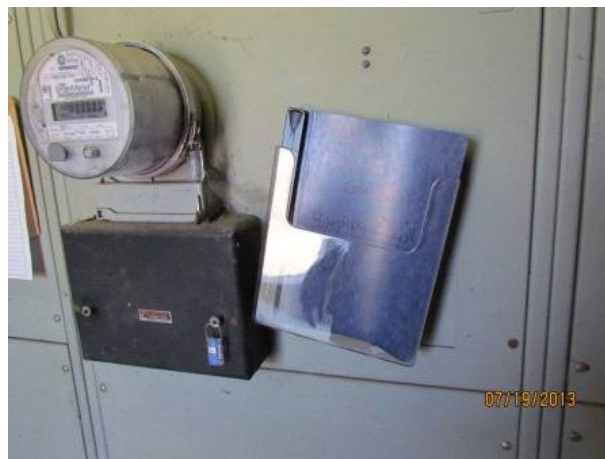
Levee Mile Report Line	2
Start Levee Mile	0.00
End Levee Mile	0.00
Location	
Category	Pump Stations
Item	Operation & Maintenance Manual

View of the O&M manual inside the pumping plant.

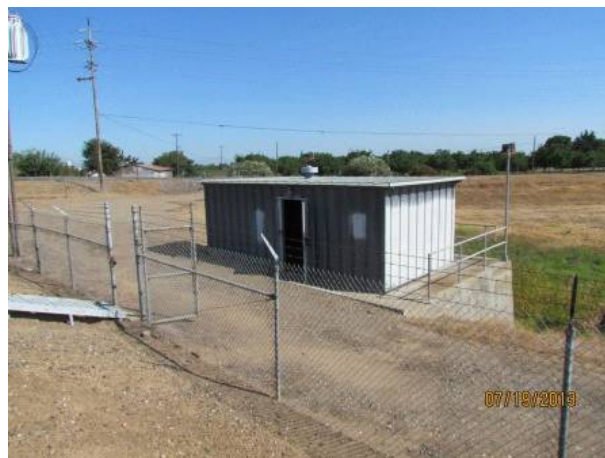
Levee Mile Report Line	3
Start Levee Mile	0.00
End Levee Mile	0.00
Location	
Category	Pump Stations
Item	Plant Building

View of the pumping plant.

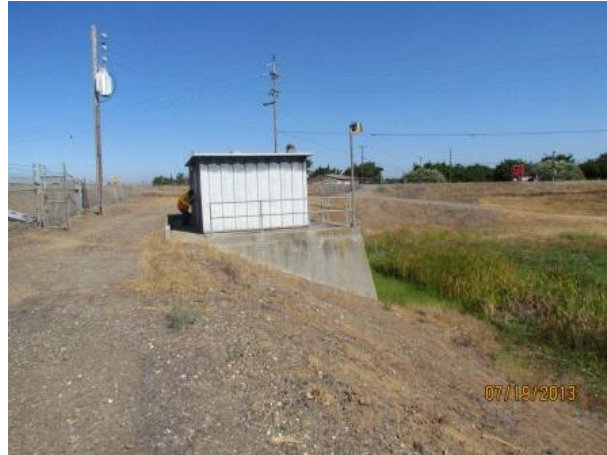
View of the guard rails around the pumping plant.

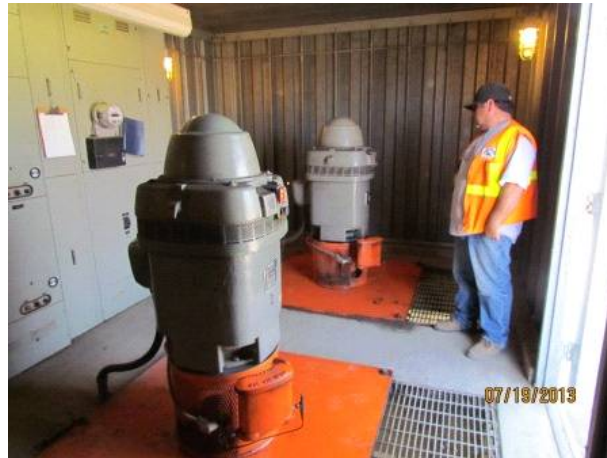
Levee Mile Report Line	7
Start Levee Mile	0.00
End Levee Mile	0.00
Location	
Category	Pump Stations
Item	Pumps

View of the pumps inside the pumping plant.

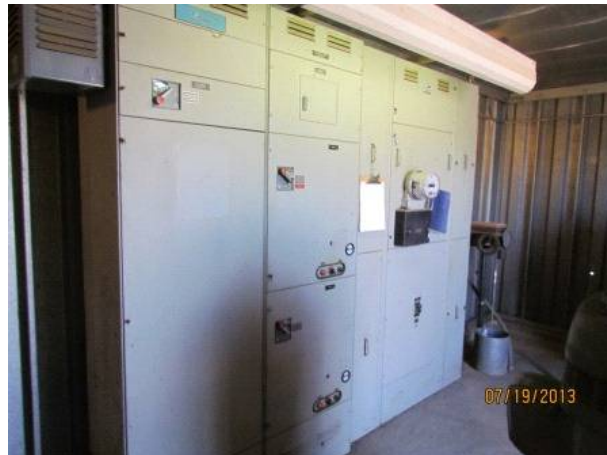
Levee Mile Report Line	10
Start Levee Mile	0.00
End Levee Mile	0.00
Location	
Category	Pump Stations
Item	Pump Control Systems

View of the power control systems inside the plant.

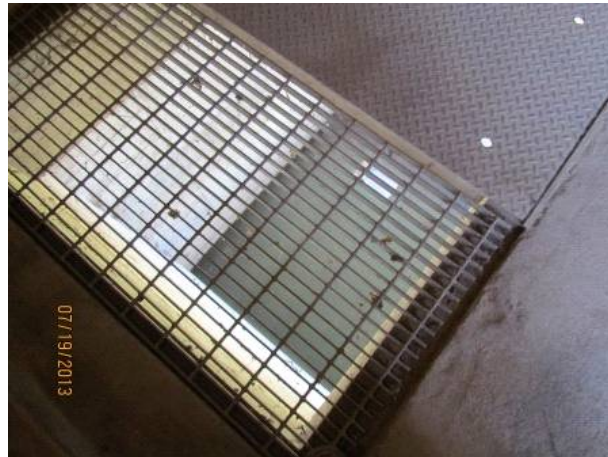
View of wet well.

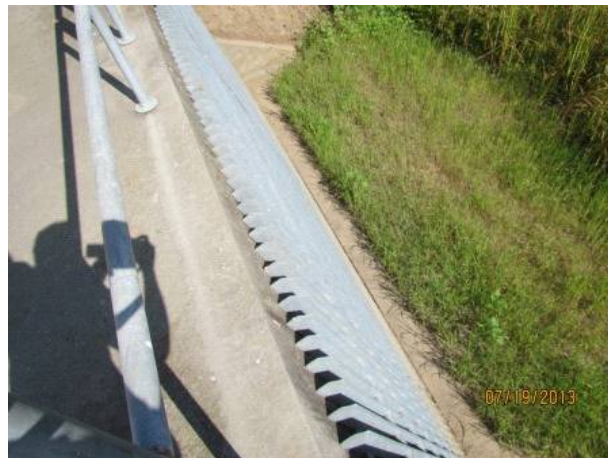
Levee Mile Report Line	12
Start Levee Mile	0.00
End Levee Mile	0.00
Location	
Category	Pump Stations
Item	Trash Racks

View of the trash racks.

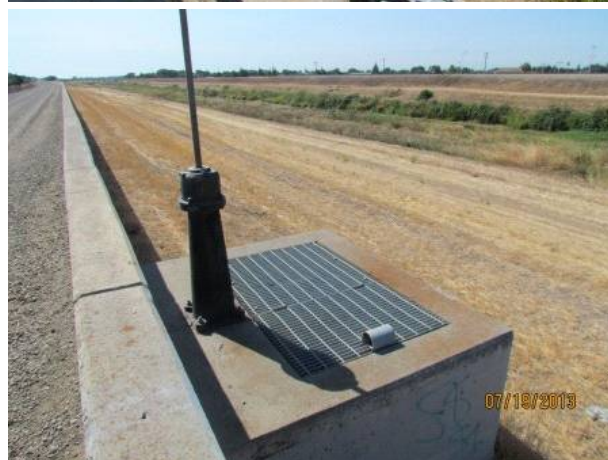
Levee Mile Report Line	14
Start Levee Mile	0.00
End Levee Mile	0.00
Location	
Category	Pump Stations
Item	Sluice / Slide Gates

View of the slide gate.

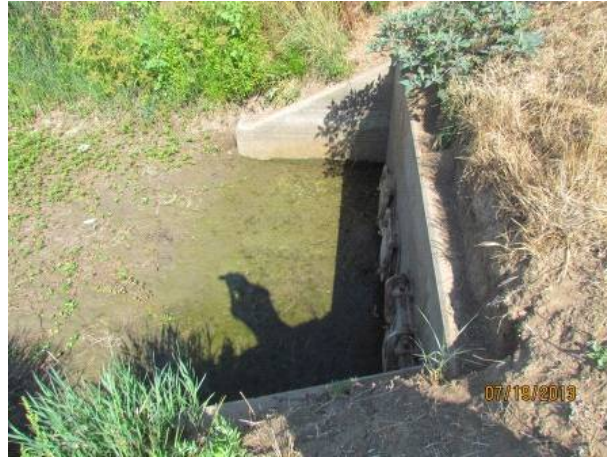
View of the flap gates.
